What do I do if the PADM 15.5.x to 20.0.0 firmware update process gets stuck?**Symptom**

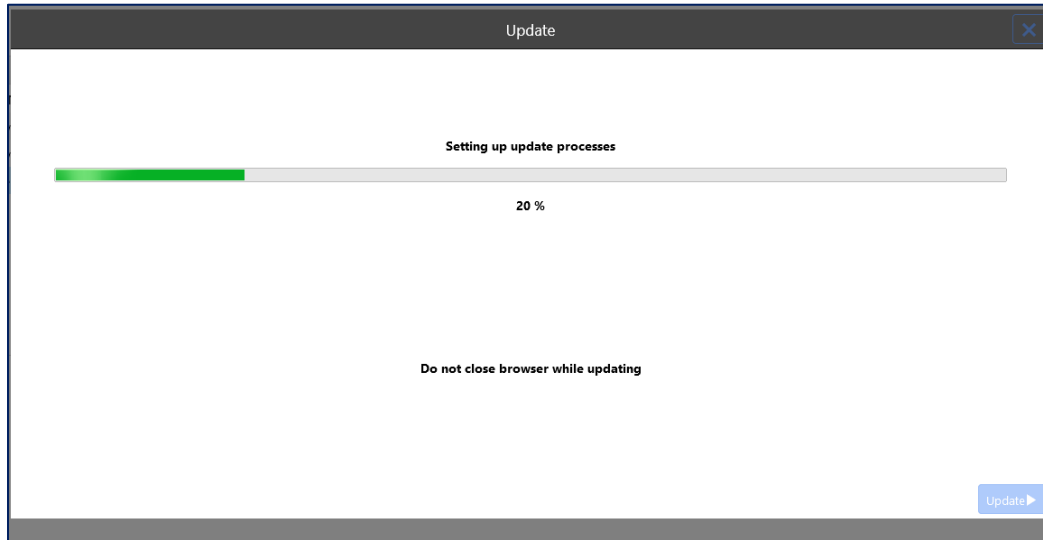
Under certain conditions, when executing a firmware update of an LX Platform device (e.g. WEBCARDLX) from version 15.5.x to version 20.0.0, the process will appear to get stuck. Specifically, the graphical and numerical progress indicator will freeze at a certain value. An example is shown below. If this indicator still appears 20 minutes after starting the update, resolve by following the instructions below.

Close the browser window, then open a new one and access the device again, i.e. enter its IP address in the browser search bar. There are two potential outcomes:

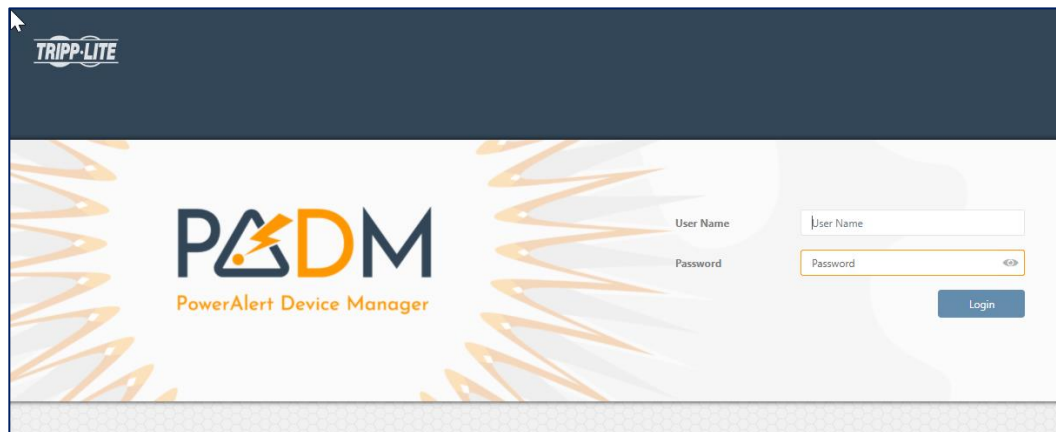
1. If the following logon screen appears, the firmware update was successful. No further actions need to be taken.

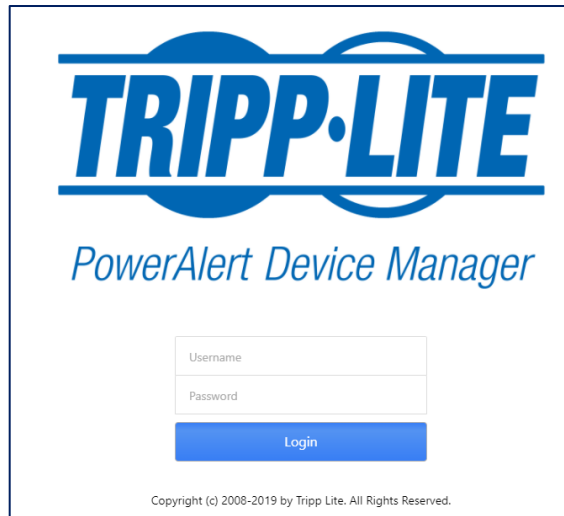
2. If the same logon screen appears as before (image below), log in again. The Event Log should contain an entry related to the update; see bottom image.

2020-09-03 20:47:06	PowerAlert stopped
2020-09-03 20:15:20	Upgrade failed. No free space available for the upgrade, free space=829456384
2020-09-03 20:06:48	PowerAlert started

To ensure that sufficient free space is available for the update to version 20.0.0, first perform an update to version 15.5.7. Even if the device is currently running version 15.5.7, update it again to version 15.5.7 [refer to the URL and image below for downloading this version].

Note that resetting the LX card or performing a Factory-level reset will NOT resolve the issue; an update to version 15.5.7 must be performed.

Upon completing the update to version 15.5.7, perform the update to version 20.0.0.
